FRENCH RIVER BASIN  
CHARLTON, MASSACHUSETTS

LITTLE NUGGET LAKE DAM  
MA 00103

**PHASE I INSPECTION REPORT  
NATIONAL DAM INSPECTION PROGRAM**

OCTOBER 1978

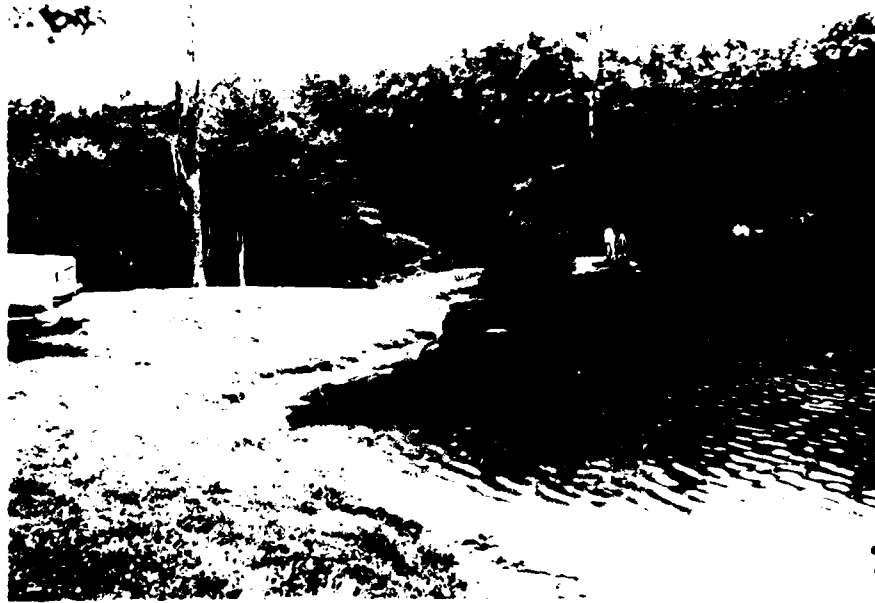
VIEW FROM UPSTREAM OF EAST ABUTMENT

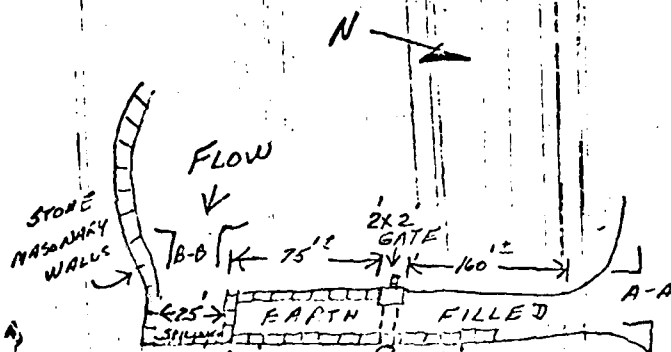
LEAKS  
BETWEEN LOGS  
& MORTAR CO STONE  
WALL -  
6/26/72  
AKT

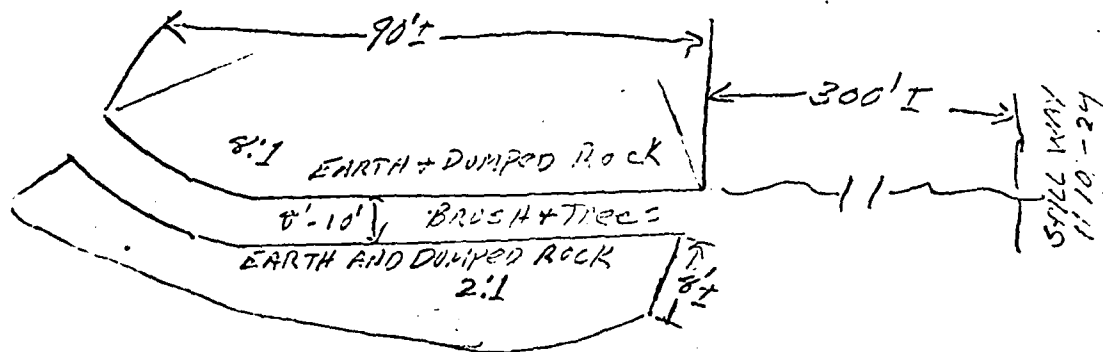
Draw # 3-14-54-24

This area cannot be used as an emergency spillway, as no means to control flow of water.
